# **FAA/Skyward Memorandum of Agreement (MOA) Bimonthly Report**

**March 2022\***

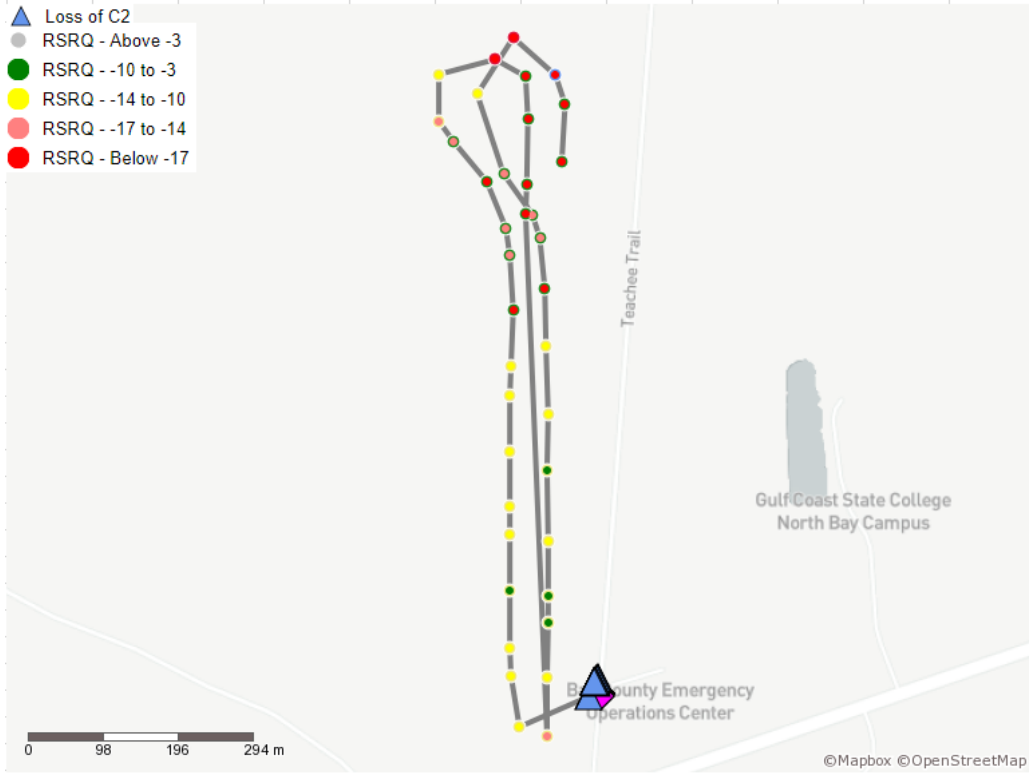
Figure 9.3.1.1 Panama City Beach RTL events (File: CTC0421042\_12\_07\_21-214641\_Flight2\_2000.1)

Flight 2 on 12/07: RTL was observed at approximately 214819 and heartbeat loss was reported around 214808. Based on the time delta it can be observed that the RTL triggered after 10s of heartbeat loss as planned. However, no RF degradation was observed during this time period. PCI 195 was reported as serving before RTL, during QRTL and until the UA landed. Figure 9.3.1.1 is produced for this event.

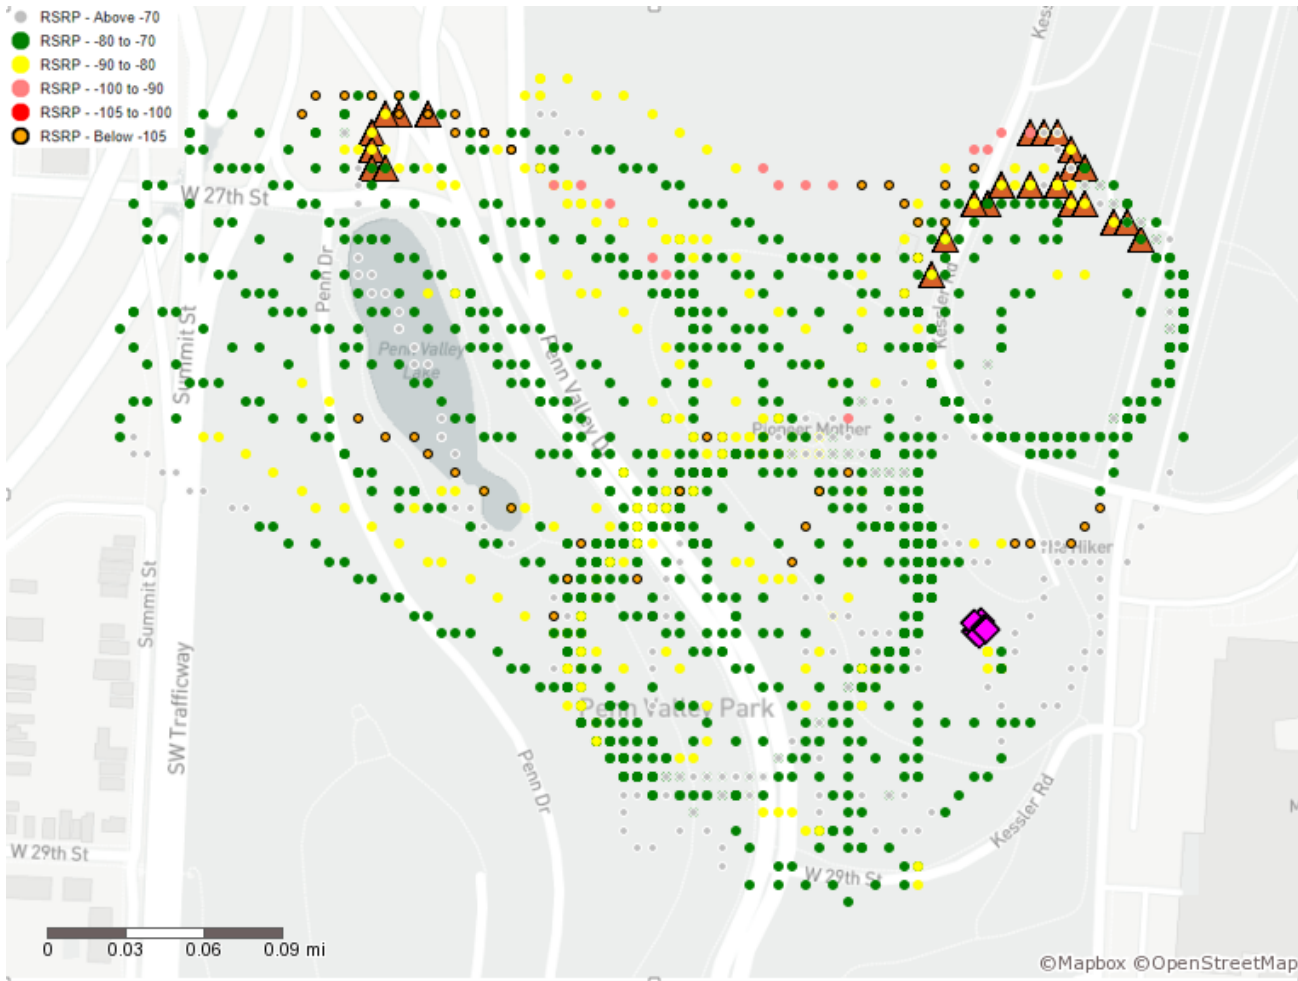
Figure 9.3.3.1.2 RSRP plot with RTL events

12/14/2021 Flight 1: There was one occurrence of RTL reported in this flight. Based on the observed number of cells serving (Figure 9.3.3.1.3 PCI plot with RTL events) UA in the area, it can be noted that the area lacked RF dominance at the altitude where the UA was flying. Furthermore it can also be observed that there was frequent change in band and PCI throughout the flight (Figure 9.3.3.1.4 PCI and Band plot along with Loss of C2 indication). It can also be noted that the RSRQ in the area is poor (Figure 9.3.3.1.1 RSRQ plot with RTL events). However, RSRP does not show a large degradation preceding the loss of C2 event (Figure 9.3.3.1.2 RSRP plot with RTL events).

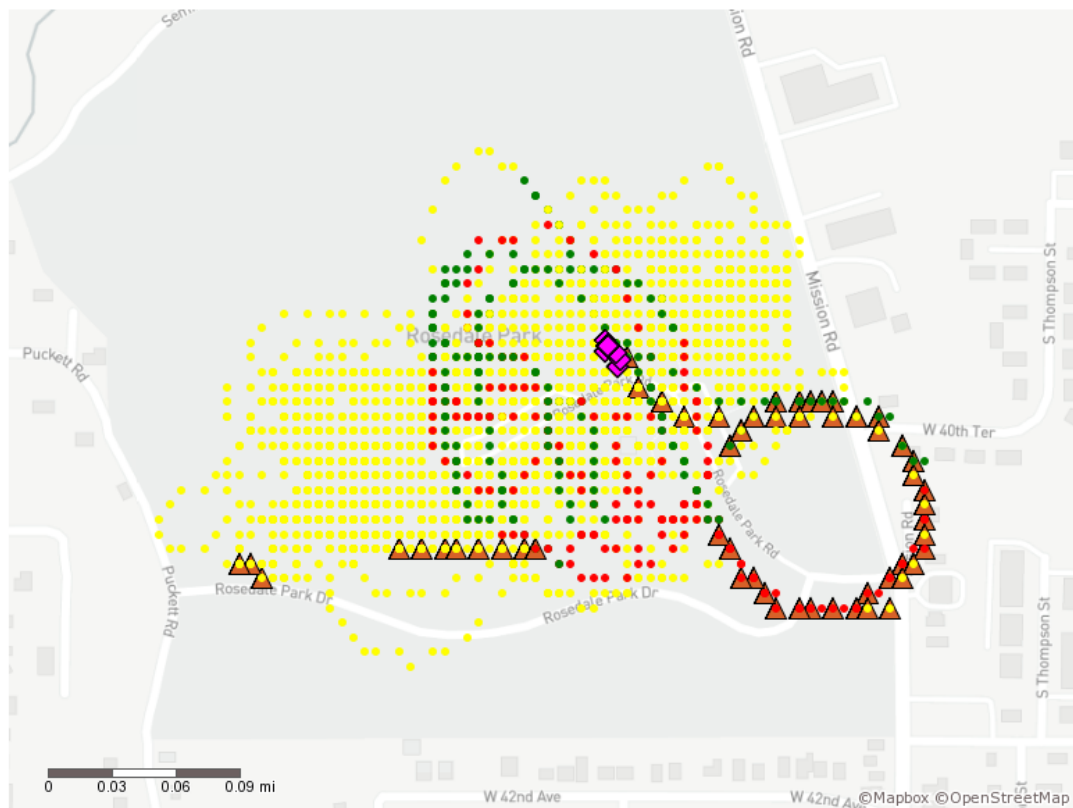
Figure 9.3.3.2.2 Flight #4 on 12/18/2021 RSRQ plot with loss of C2 points along with GCS location

Flight #4 on 12/18/2021: Loss of C2 was declared at approximately 182420 and RTL was triggered at 182426. Per the system design of the UX11, loss of C2 is noted when heartbeat is missed for 5s. Based on this it can be confirmed that the automatic invocation of “landing” aka “RTL” occurred per our desired timer setting of 10s.

Preceding the loss of C2 leading up to the RTL event, a change in roll was observed to go from approximately -30 to approximately +30 degrees, heading changed from approximately 230 to approximately 140 degrees, and RSRP dropped from approximately -68 to approximately -79dBm. Presence of the same PCI and band but different ECI (column BS in Figure 9.2.3.2.1 Log file snippet of RF parameters) suggest that there might be PCI collision in this area. It is to be noted that at approximately 182429 i.e after around 14s, the UA deregistered from the network and did not reconnect until 38 seconds later. Layer3 messages, which we are not able to capture, would need to be analyzed in order to understand what caused this behavior.

It can also be noted from Figure 9.2.3.2.2 that there were other temporary interruptions during this flight.

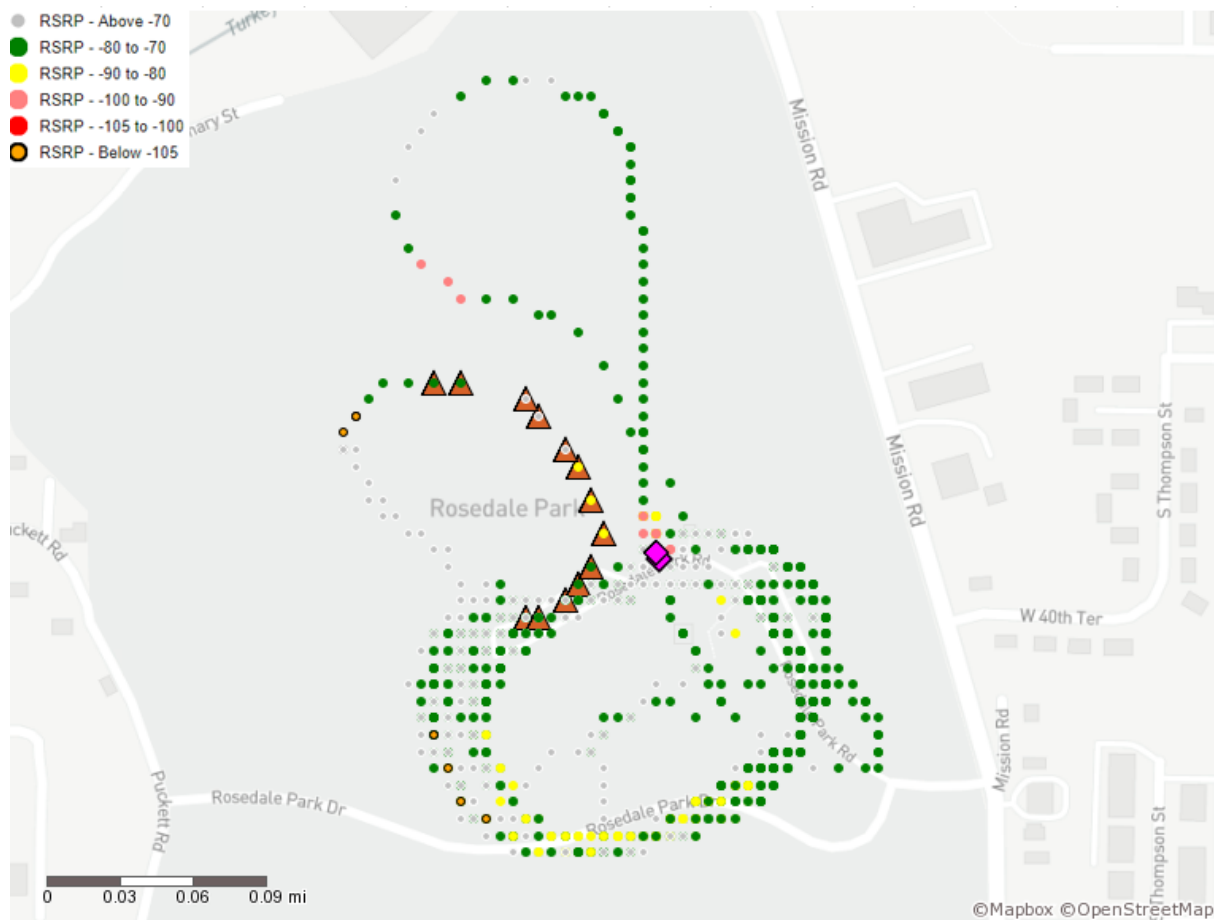
Figure 9.3.3.2.6 Flight #3 on 01/08/2022 RSRP plot with loss of C2 points and GCS location

Flight #3 on 01/08/2022: This flight had 1 RTL invocation reported. It can be noted that immediately after loss of C2 was at approximately 160304, there is an absence of RF data for approximately 15 seconds until 160319 (Figure 9.3.3.2.8). The UA invoked RTL at 160324, i.e., after around 25 seconds (based on system knowledge where initial loss of C2 is recorded after 5s without a logged heartbeat). It can be noted that there was a change in PCI from 444 to 126, Band changed from 4 to 13 (Figure 9.3.3.2.8), RSRQ changed from -14 to -20 (Figure 9.3.3.2.9), and heading changed from 200 degree to 35 degree. The absence of RF parameters for 15s is unexplainable, however, it can be observed that the loss of link was likely due to an abrupt change in heading which might have triggered an inter-frequency HO. It is also noted that the UA reconnected after around 39 seconds (160300 to 160339).
