# UTC Spotlight

University of Texas Rio Grande Valley

Quarterly  
Issue 4  
October 2024

## Effects of Long-Term Inactivity on Railcar Bearings

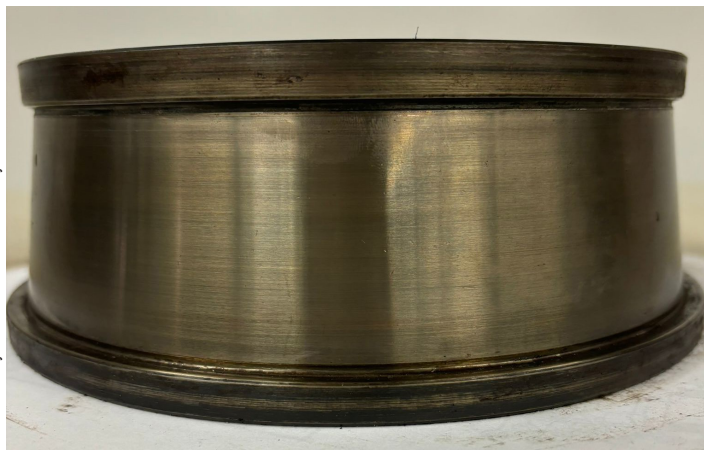
After the test, both pulled bearings were opened and inspected. Figures 2 and 3 show cones from bearings L7 and R7, respectively. Consistent with the vibration measurements, R7 showed large areas of *spalling*, meaning flaking of metal off the surface. More importantly, one of the cones in R7 had a fracture across its entire width, as shown in Figure 4. In rail service, this could cause the cone to lose its grip on the axle, rapidly leading to overheating and catastrophic failure.

Figure 2: The inner ring (cone) raceway of bearing L7, showing no signs of damage.

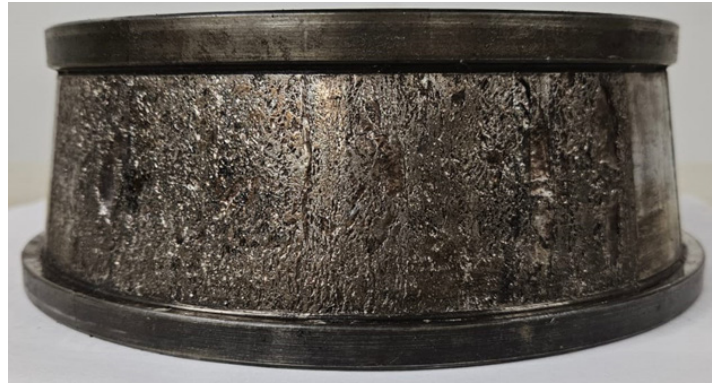
Figure 3: The inner ring (cone) raceway of bearing R7, showing severe damage over a large area.

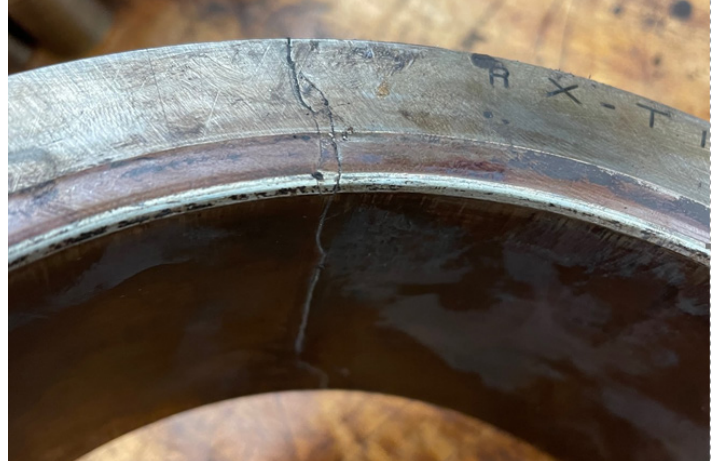
Finally, the test was terminated early at 93,554 miles (150,561 km) due to impending failure: bearing R7 began *indexing* under full load. Normally, the inner ring (the *cone*) grips the spinning axle and rotates with it, while the outer ring (the *cup*) is stationary and held in place by a bearing adapter. Indexing is a condition in which internal friction is so high that the outer ring moves, scraping against the bearing adapter that is supposed to hold it stationary. If continuous, this a dangerous condition requiring termination of the lab test.

Figure 4: Fractured cone in bearing R7. This fracture could cause the cone to lose its grip on the axle, leading to indexing and catastrophic failure.
