# **FAA/Skyward Memorandum of Agreement (MOA) Bimonthly Report**

**January 2022\***

Submitted by: Bri O'Neill

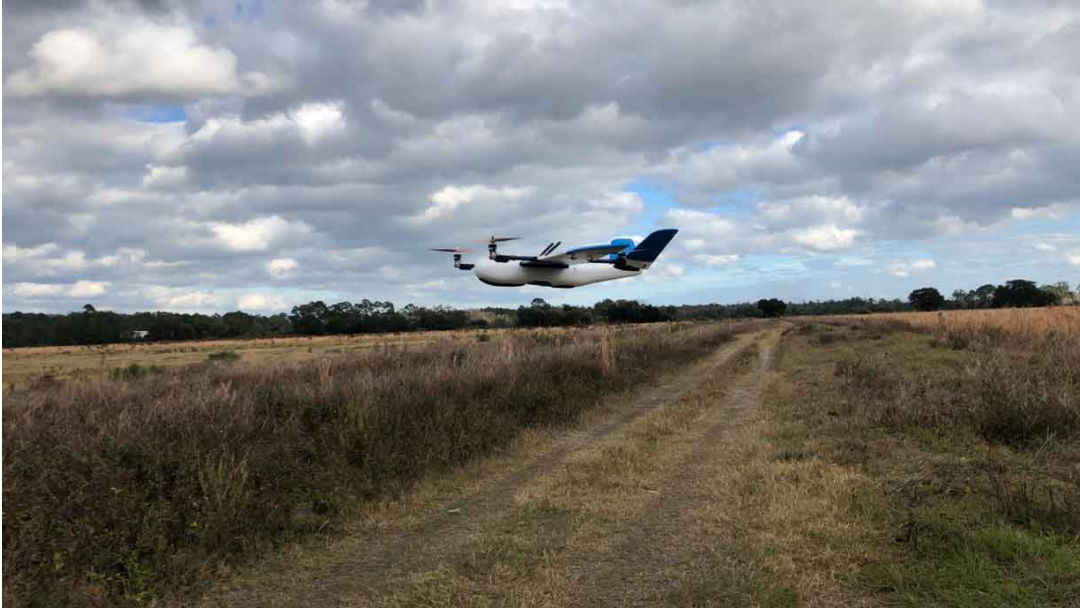
**Figure 3.2 Sentaero VTOL FW LTE**

Daytona, FL Photo credit: Tanmay Naik of Censys Technologies

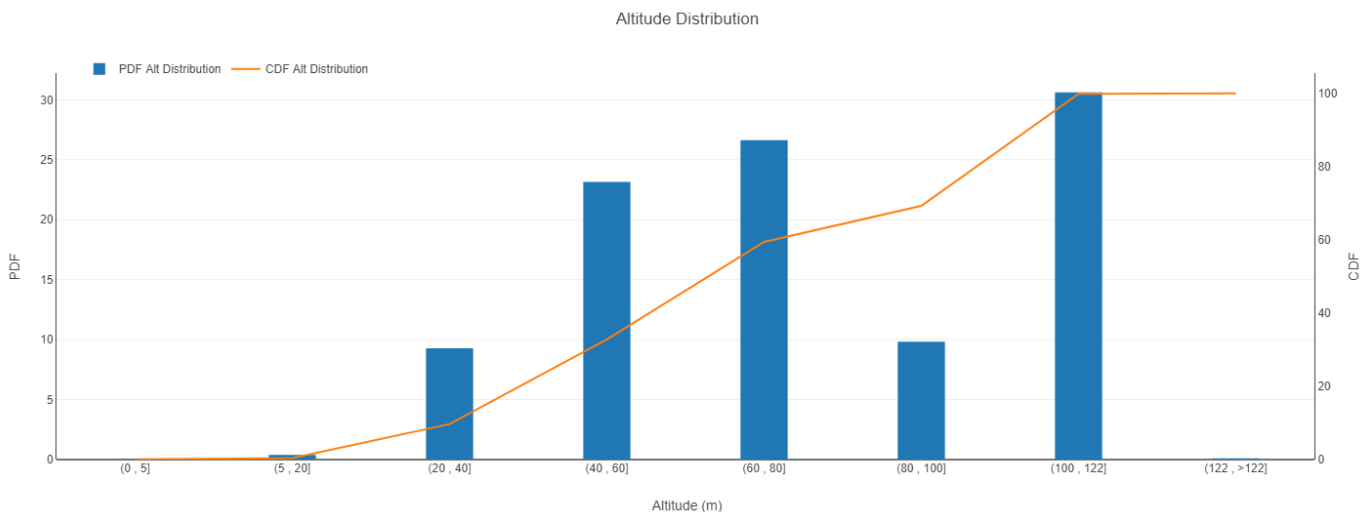
**Figure 8.2.1 Operational Altitude Distribution Chart**

Altitude reporting mechanism: Barometric altitude. Calibrated at the takeoff location.  
Average altitude: 79m

Metric	Altitude (m)
5th Percentile	39
50th percentile	79
99th Percentile	120
Max	131* (*around 119 records above 122m out of 109380 records i.e. 0.11%)

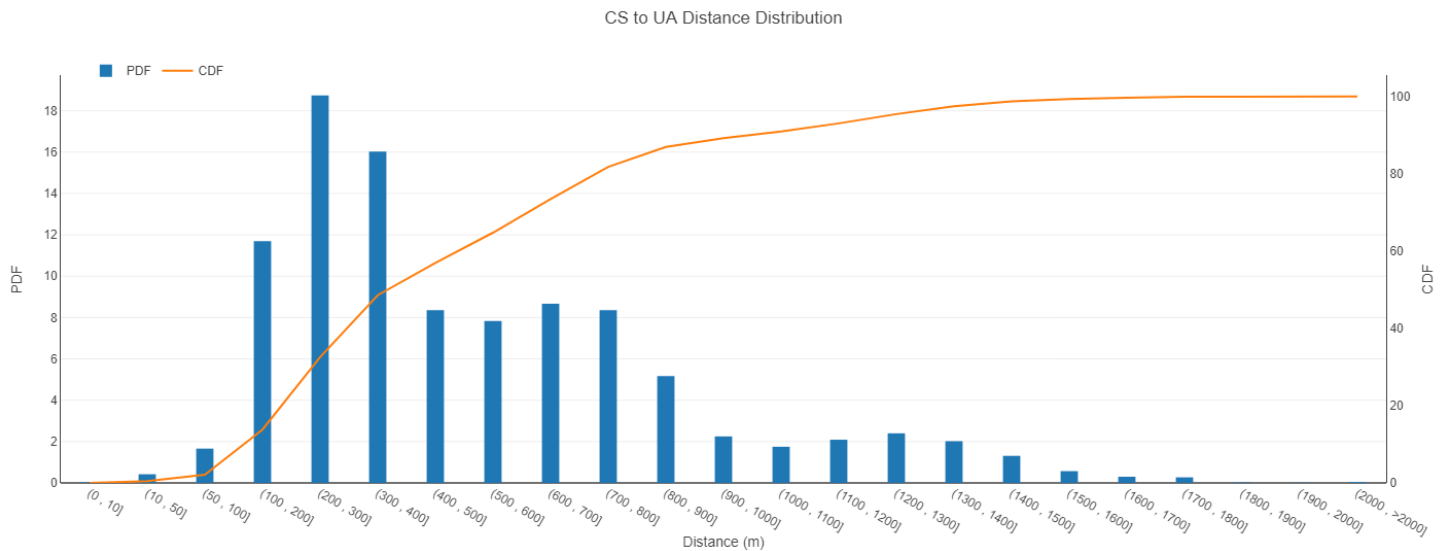
**Figure 8.3.1 CS to UA Distance Distribution Graph**

The “distance between the CS and UA” is defined as the calculated linear distance. This parameter is commonly of interest when analyzing UAS data due to the use of line of sight radios connecting the CS and UA. In this case the UA is connected to the CS via the cellular network, therefore the “distance between the CS and UA” does not depict the traveled distance of the communication link. See Section 6.2 for a description of the network architecture and the traveled distance of the communication link.

Average distance between UA and CS: 418m

Maximum distance between UA and CS: 2126m

Metric	Altitude (m)
5th Percentile	134

50th percentile	418
95th Percentile	1277
Max	2126

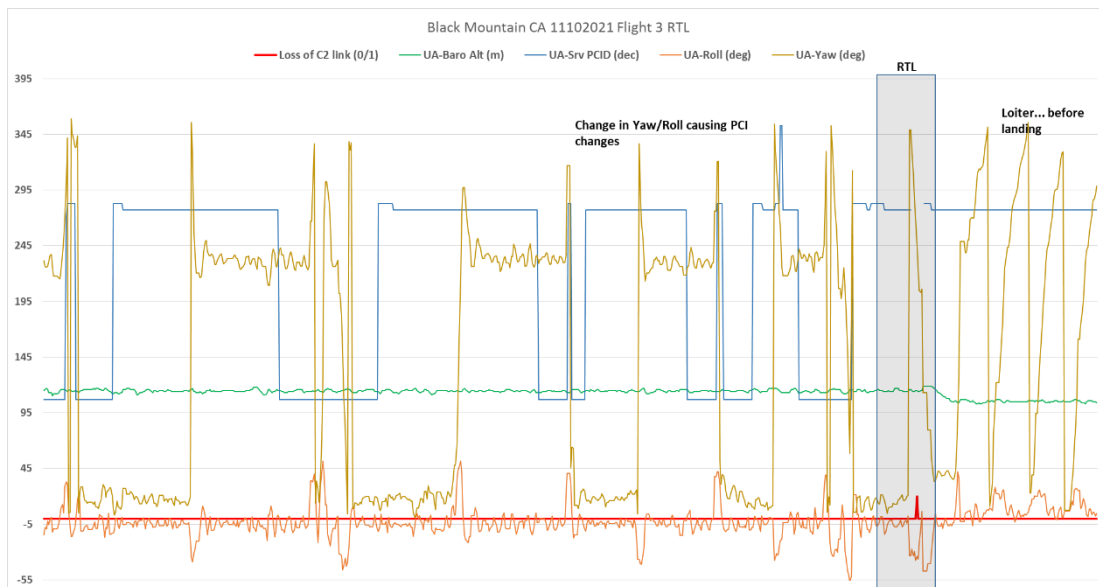
It was noted that the RTL event was followed by what appears to be an abrupt change in yaw and roll of the aircraft. This abrupt change could have caused simultaneous degradation of the serving cell signal and improvement of the neighbor signal strength. Such a change in signal strength (depicted in Figure 9.2.2.1) typically triggers a handover sequence per the design of the cellular network. Based on the available data, it is suspected that the UA lost the data connection to the LTE network due to an unsuccessful handover. It is notable that while the UA was executing the loiter command (shown after the RTL event in Figure 9.2.2.2), the changes in yaw and roll were gradual and PCI changes were infrequent. There were no additional reports of RTL during the loiter period after the initial RTL event.

Figure 9.2.2.2 Aircraft Yaw, Roll vs PCI along with Altitude and Heartbeat loss events

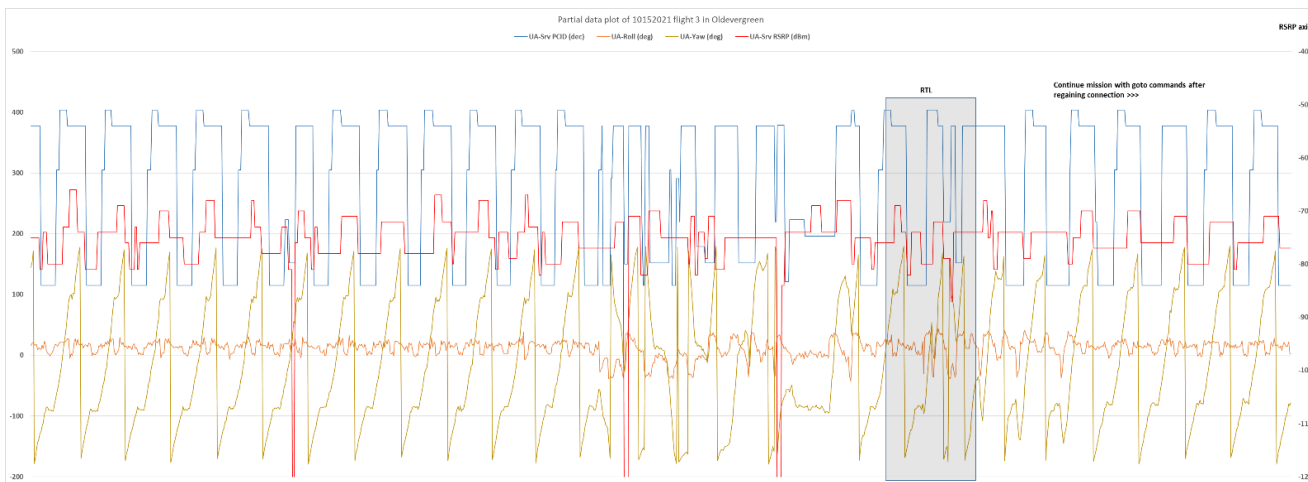
Figure 9.2.3.3 Old Evergreen Flight 3 UA PCI, RSRP along with aircraft Roll and Yaw

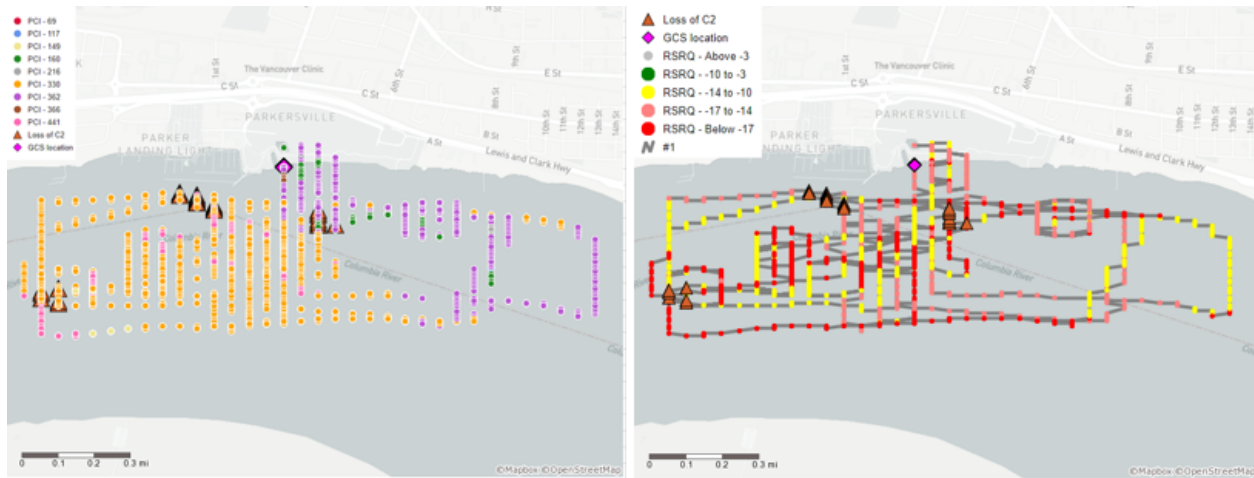
Figures 9.2.4.1, 9.2.4.2 and 9.2.4.3 show the flight path and associated RF data (refer to legend). Figure 9.2.4.1 shows that there were reports of a high quantity of different serving PCs in the area. Occurrences of loss of C2 link occur in the same general geographic area, except in one case where the occurrences of loss C2 link appear throughout the flight route (Figure 9.2.4.3).

Figure 9.2.4.1 Washougal 10/08/2021 Flight 1 RTL events with PCI (left) and RSRQ (right) information
