# **FAA/Skyward Memorandum of Agreement (MOA) Bimonthly Report**

**November 2021\***

## 9.1 8/17/2021 RTL Root Cause Analysis

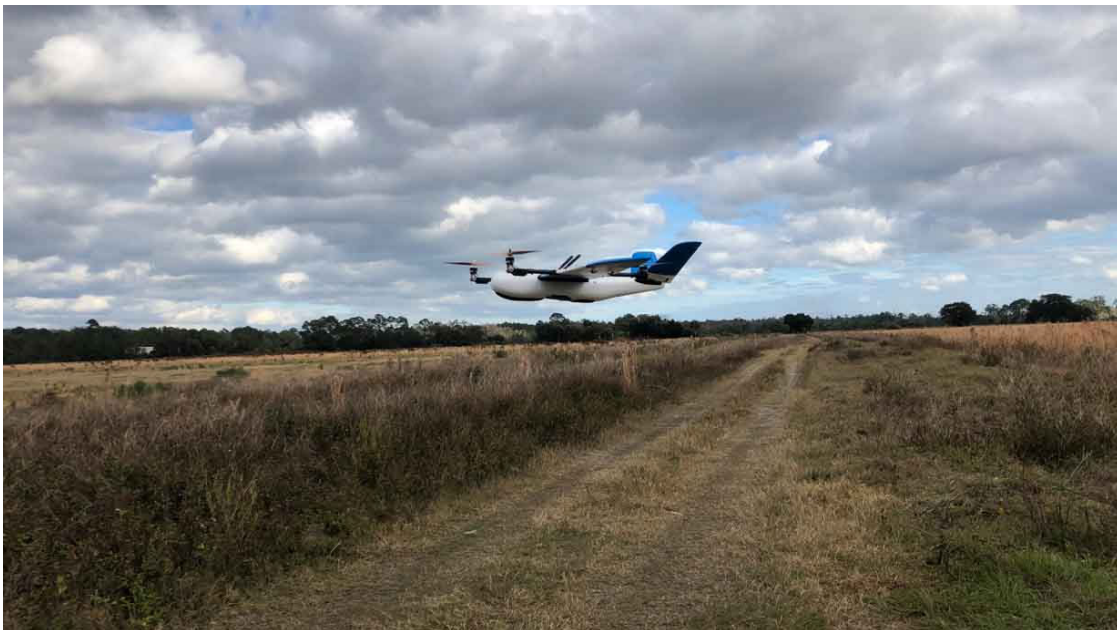
Figure 3.1 Sentaero VTOL FW LTE

Uncrewed aircraft model: Sentaero VTOL FW LTE

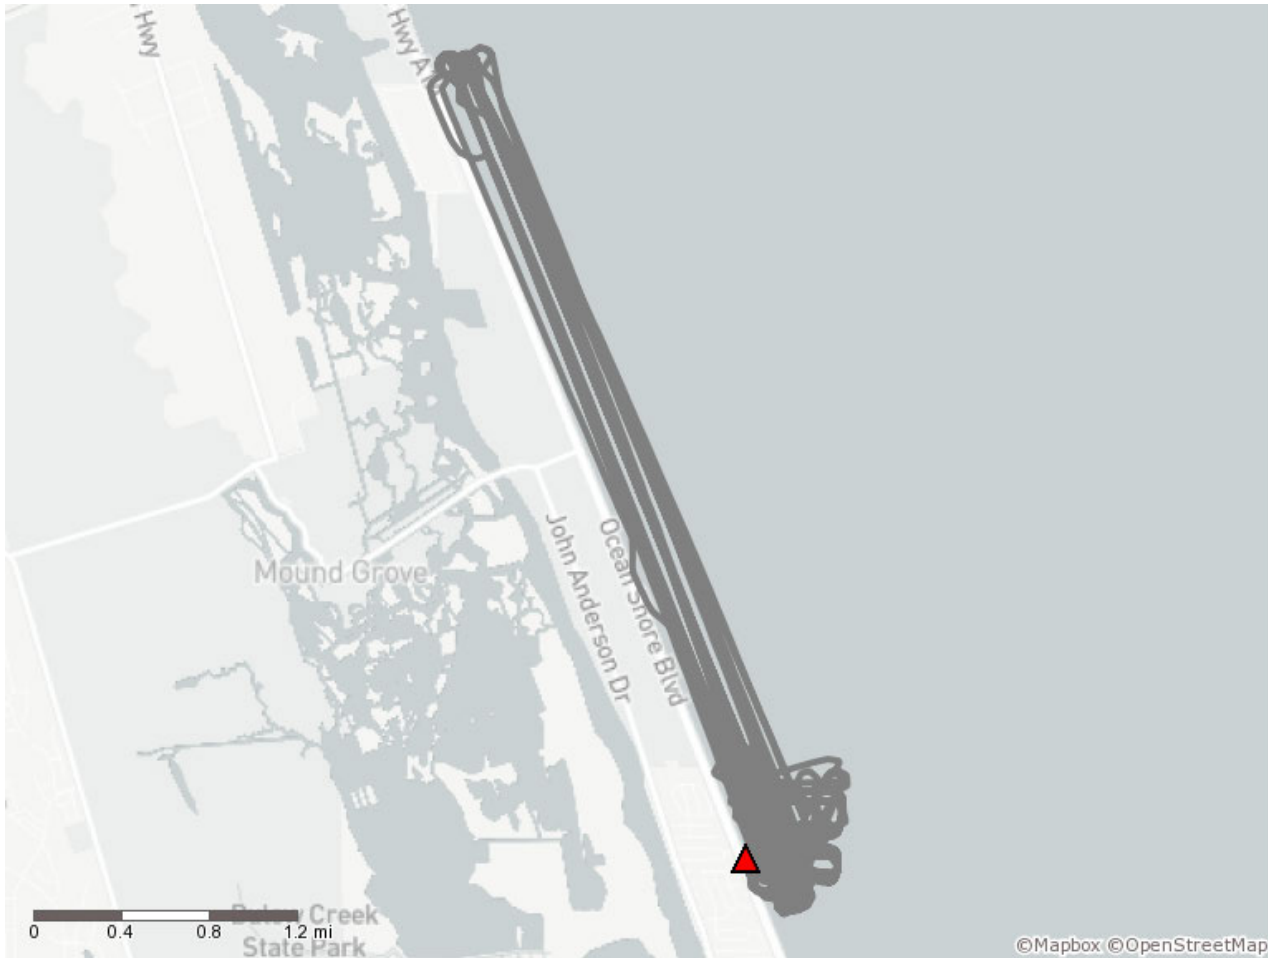
**Figure 5.1.1 Flight routes in Volusia Daytona Beach, FL**

Operation ID: DOEFLT-124  
Operational area name: Volusia Daytona Beach Florida  
Environment: Urbanized Area  
Total quantity of flight hours: 10.08 hrs  
Total quantity of flights: 10  
Average altitude: 79m (50th Percentile)  
Maximum altitude: 131m (99th percentile 121m)  
Operational Risk Assessment (ORA): Moderate  
Objective: Baseline Mobile Field/Area Survey

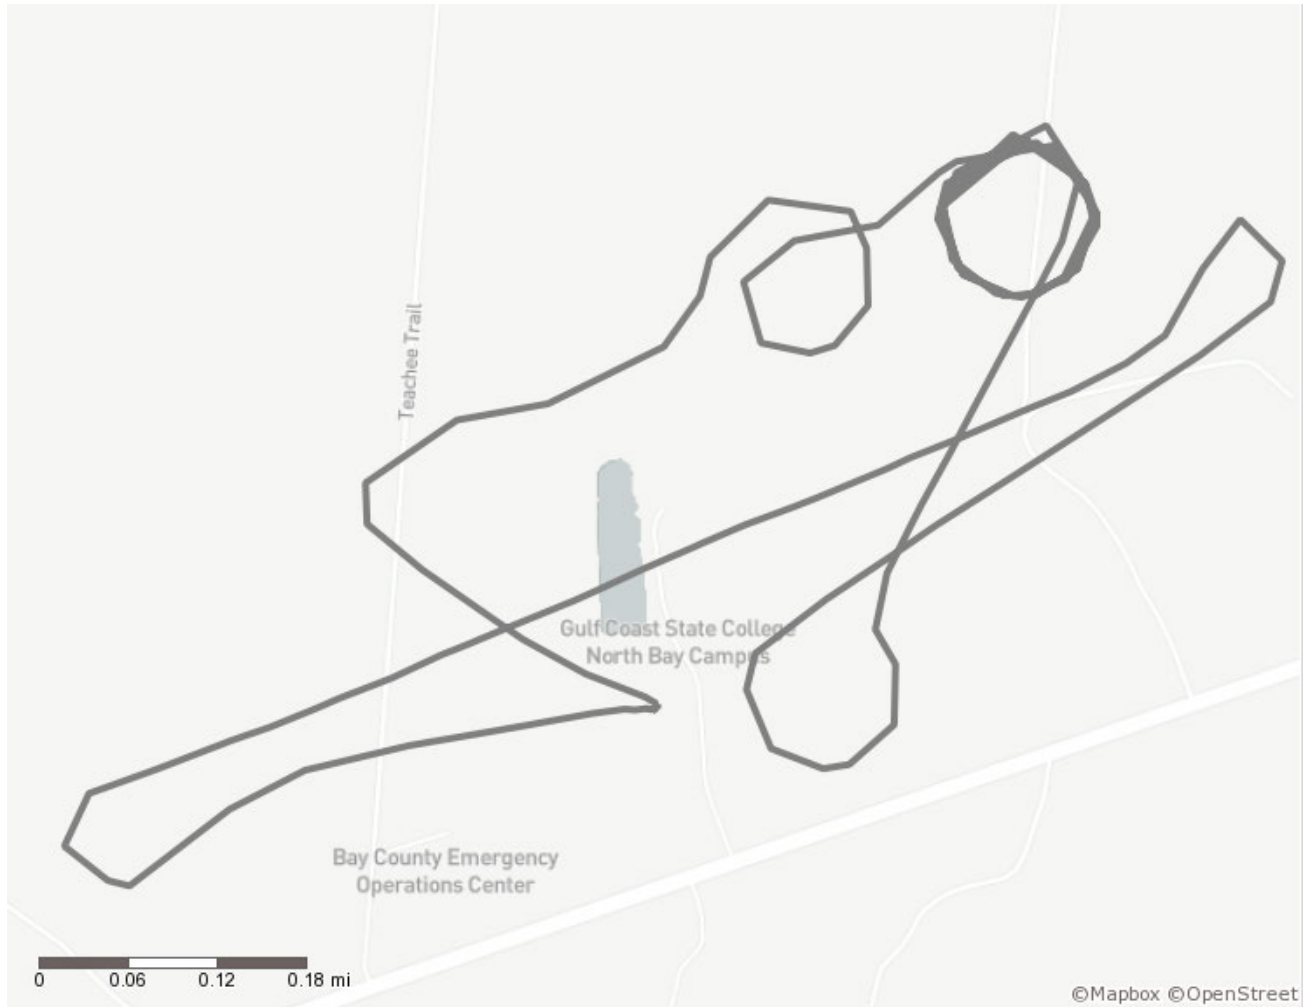
**Figure 5.2.1 Flight route in Panama City FL**

Objective: Baseline Local Infrastructure inspection, long linear inspection
