# **FAA/Skyward Memorandum of Agreement (MOA) Bimonthly Report**

**March 2022\***

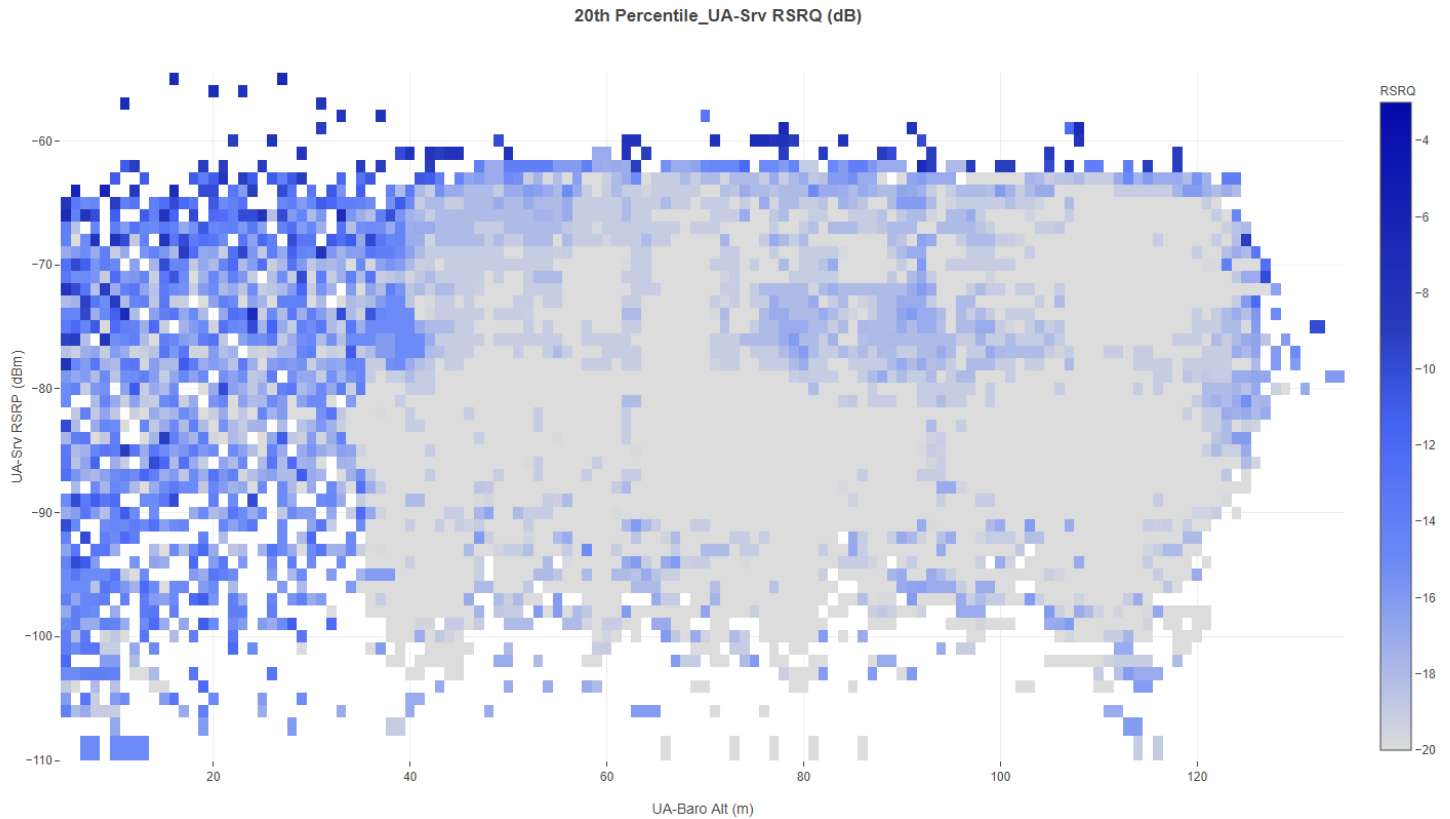
**Figure 8.6.5 Relationship between RSRP, Altitude and RSRQ**

Based on Figure 8.6.5, it can be observed that as we fly at higher altitudes and if the UA encounters weaker RSRP (less than -80dBm or so), there is a 20% chance that the value of RSRQ is less than -18dB or so.
